**Case Study – Refurbishment of Vactron 2**

**Date : April – May 2014**

**Plant No. VE 005**

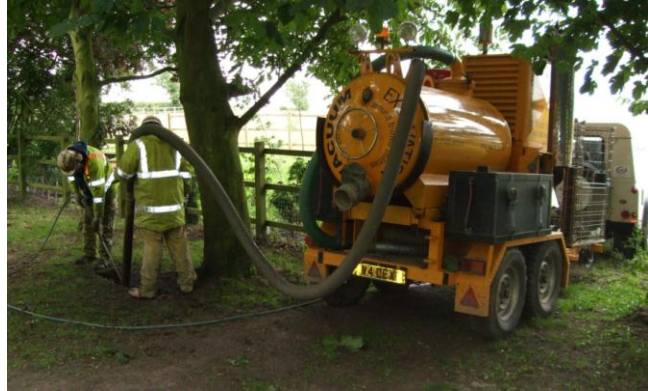
- **Ageing electrics**
- **Excessive rust patches**
- **Bring colour scheme in line with company brand**
- **Introduce new logo re-branding**
- **Too much ‘play’ in tipping bearings**
- **Preventative future maintenance**

- **Full strip down of all components**
- **Shot blasting to metal components**
- **Power coating to all metal work**
- **Re-machine tipping mechanism**
- **New electrics and dashboard to bring in line with current standards**
- **New axels and wheels**
- **New anti-freeze system**
- **New pipe work**
- **New LED beacons, side lights and working lights**
- **New hydraulic spec. water pipe work feed system**
- **New & additional E-stops**
- **New HP water system**
- **New re-brand**
- **New H&S decals**
