Case Study – Refurbishment of ‘Lydia’ Dino 3

Date: June 2013 – August 2013

Plant No. VE 008

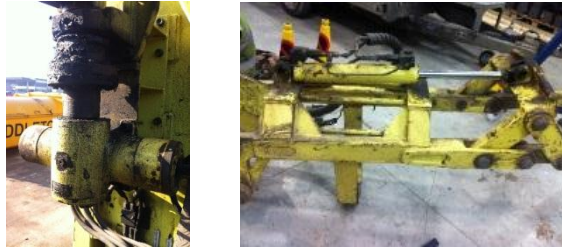
- Excessive rust patches
- Bring colour scheme in line with company brand
- Too much play in tipping bearings and arm
- Preventative future maintenance

- Full arm refurb
- Complete skip and lid refurb
- New turbine bearings and belts
- Electrical system rectified
- Replaced all hydraulic rams
- Replaced hydraulic pipework
- Replaced 2 turbine belts
- Complete re-spray and new livery to bring in line with company brand
- Replaced halogen bulbs with full LED working lights and hazard lighting
- Full service
